Manhole Inspection Summary

Manhole # S05SS1008MH

Insp Date: **9/25/06 12:42 PM**

Location Address: **5501 PARK HEIGHTS AVE**

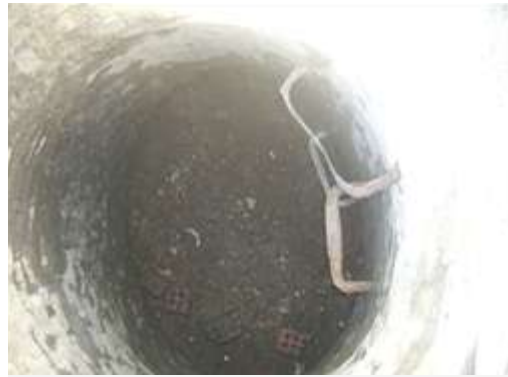
Top View

Corroded steps. Channel debris.

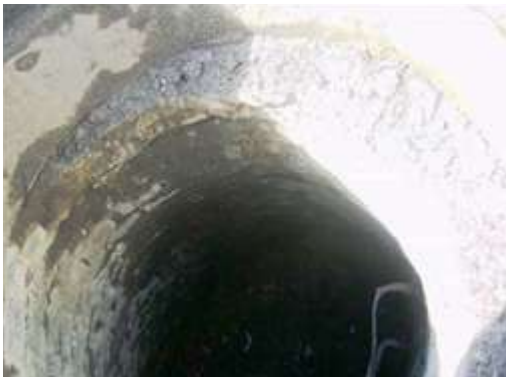
Defect

Frame leaks. Frame offset. Adjustment deterioration and infiltration. Corbel and Barrel infiltration.

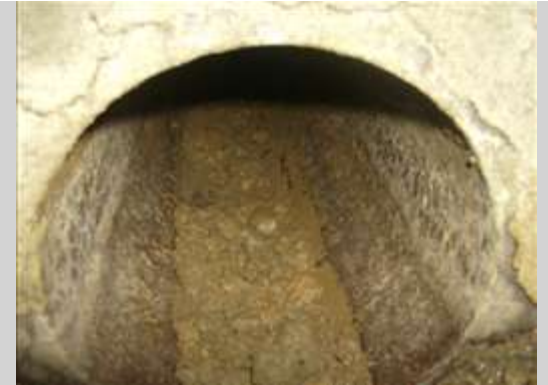
8 in. Circular Gravity Sewer
Pipe Out @ 12 O'Clock

Deposits: ☐ None ☒ **Mud** ☐ Sludge ☐ Debris ☐ Grease

Silt Depth: **0** (in.) Deposits Extent: **Light**

Infiltration: **Evidence** Pipe Seal Cond: **Unknown**
